Caucasus Traditional Building Revival

Case Study Report

THE HISTORICAL URBAN LANDSCAPE OF ORDUBAD: RESTORATION OF MONUMENTS, THE ROLE OF GARDENS, AND THE KAHRIZ WATER SYSTEM

TRADITIONAL ALIZI (ADOBE BRICK) HOUSE IN GEORGIA

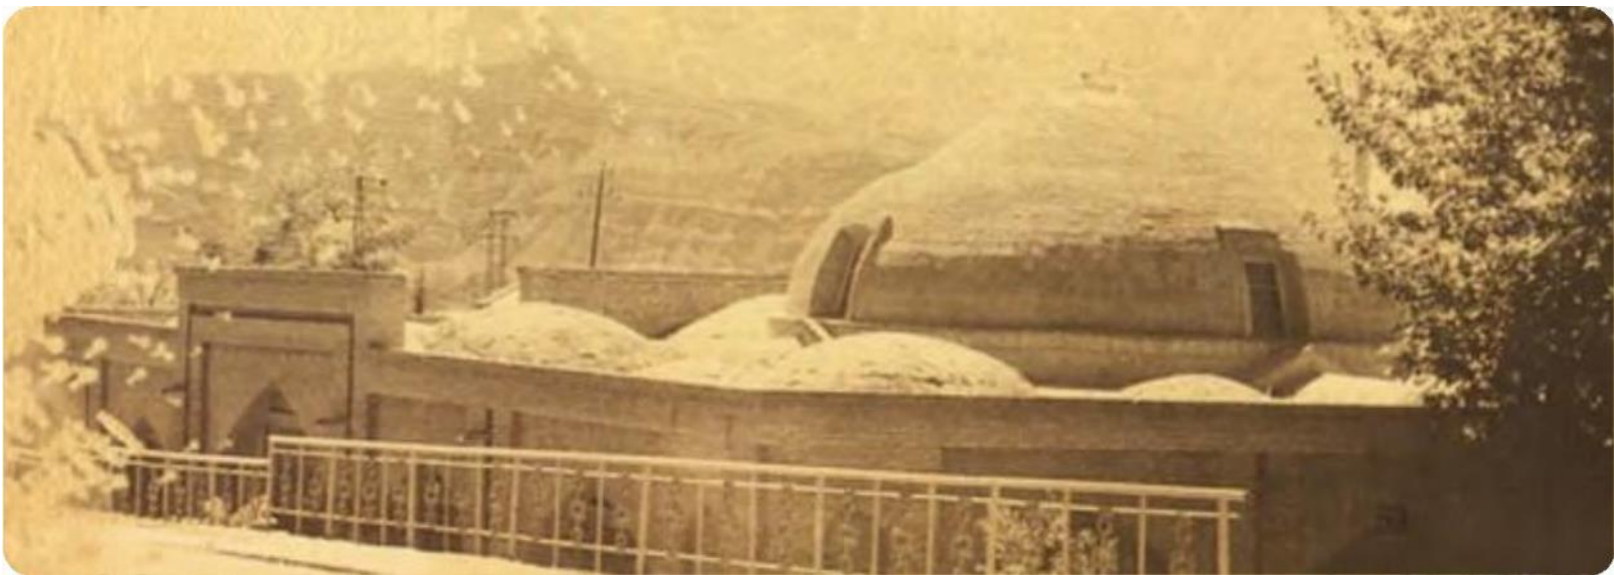
The form of the Geysariyya building in the 1980s.

The current state of the Qeysariyya building shows that it has undergone significant changes due to improper restoration. At present, major interventions have been made to its volume and façade. In particular, the building has been clad with brick facing that does not conform to its original structure, disrupting its historical appearance and material harmony.

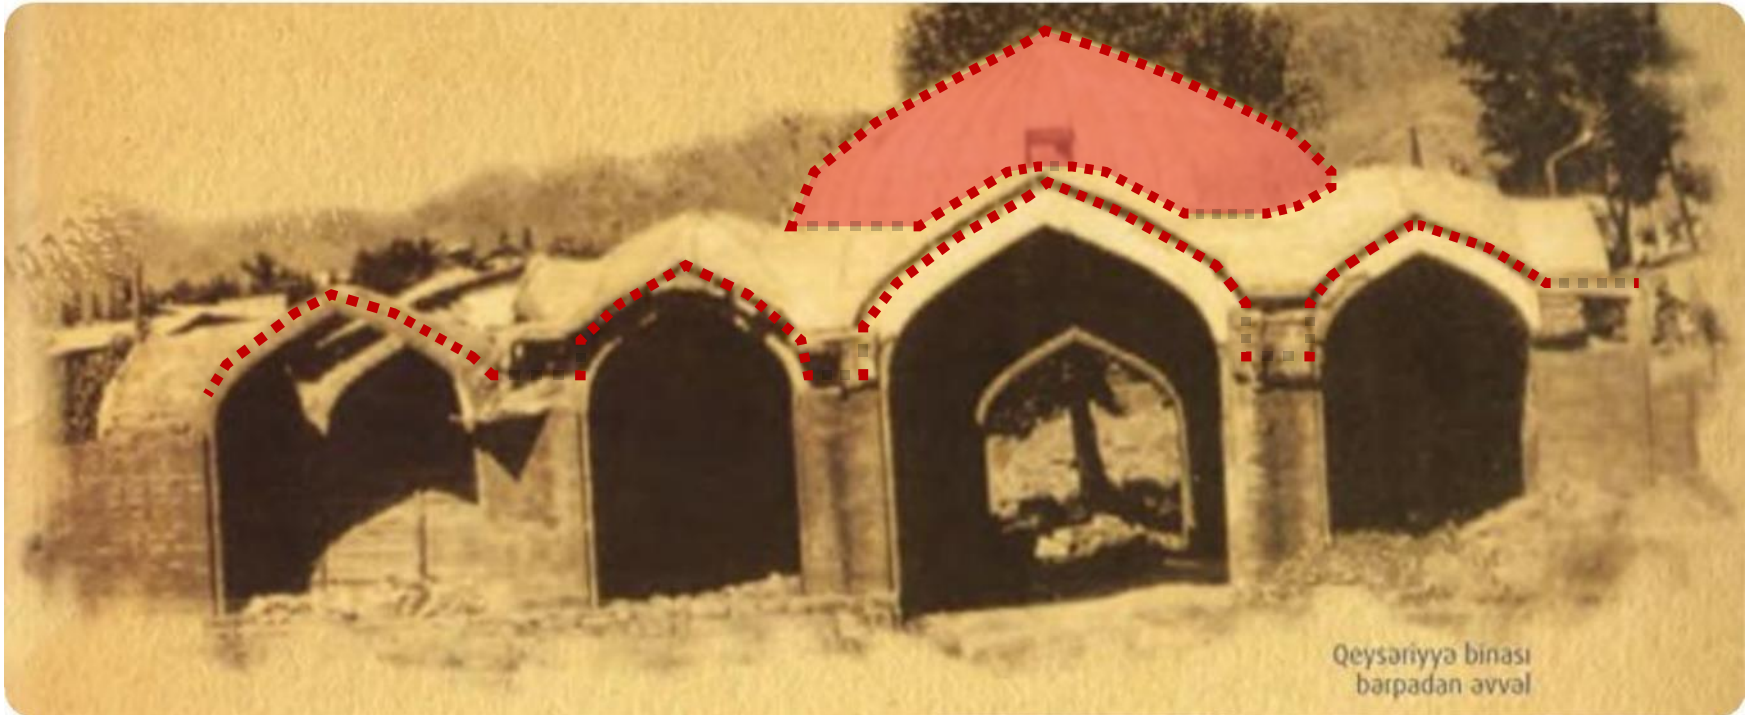
1. Volume analysis of the building's form before first restoration.

- Main dome
- Facade contour

Before restoration Geysariyya building

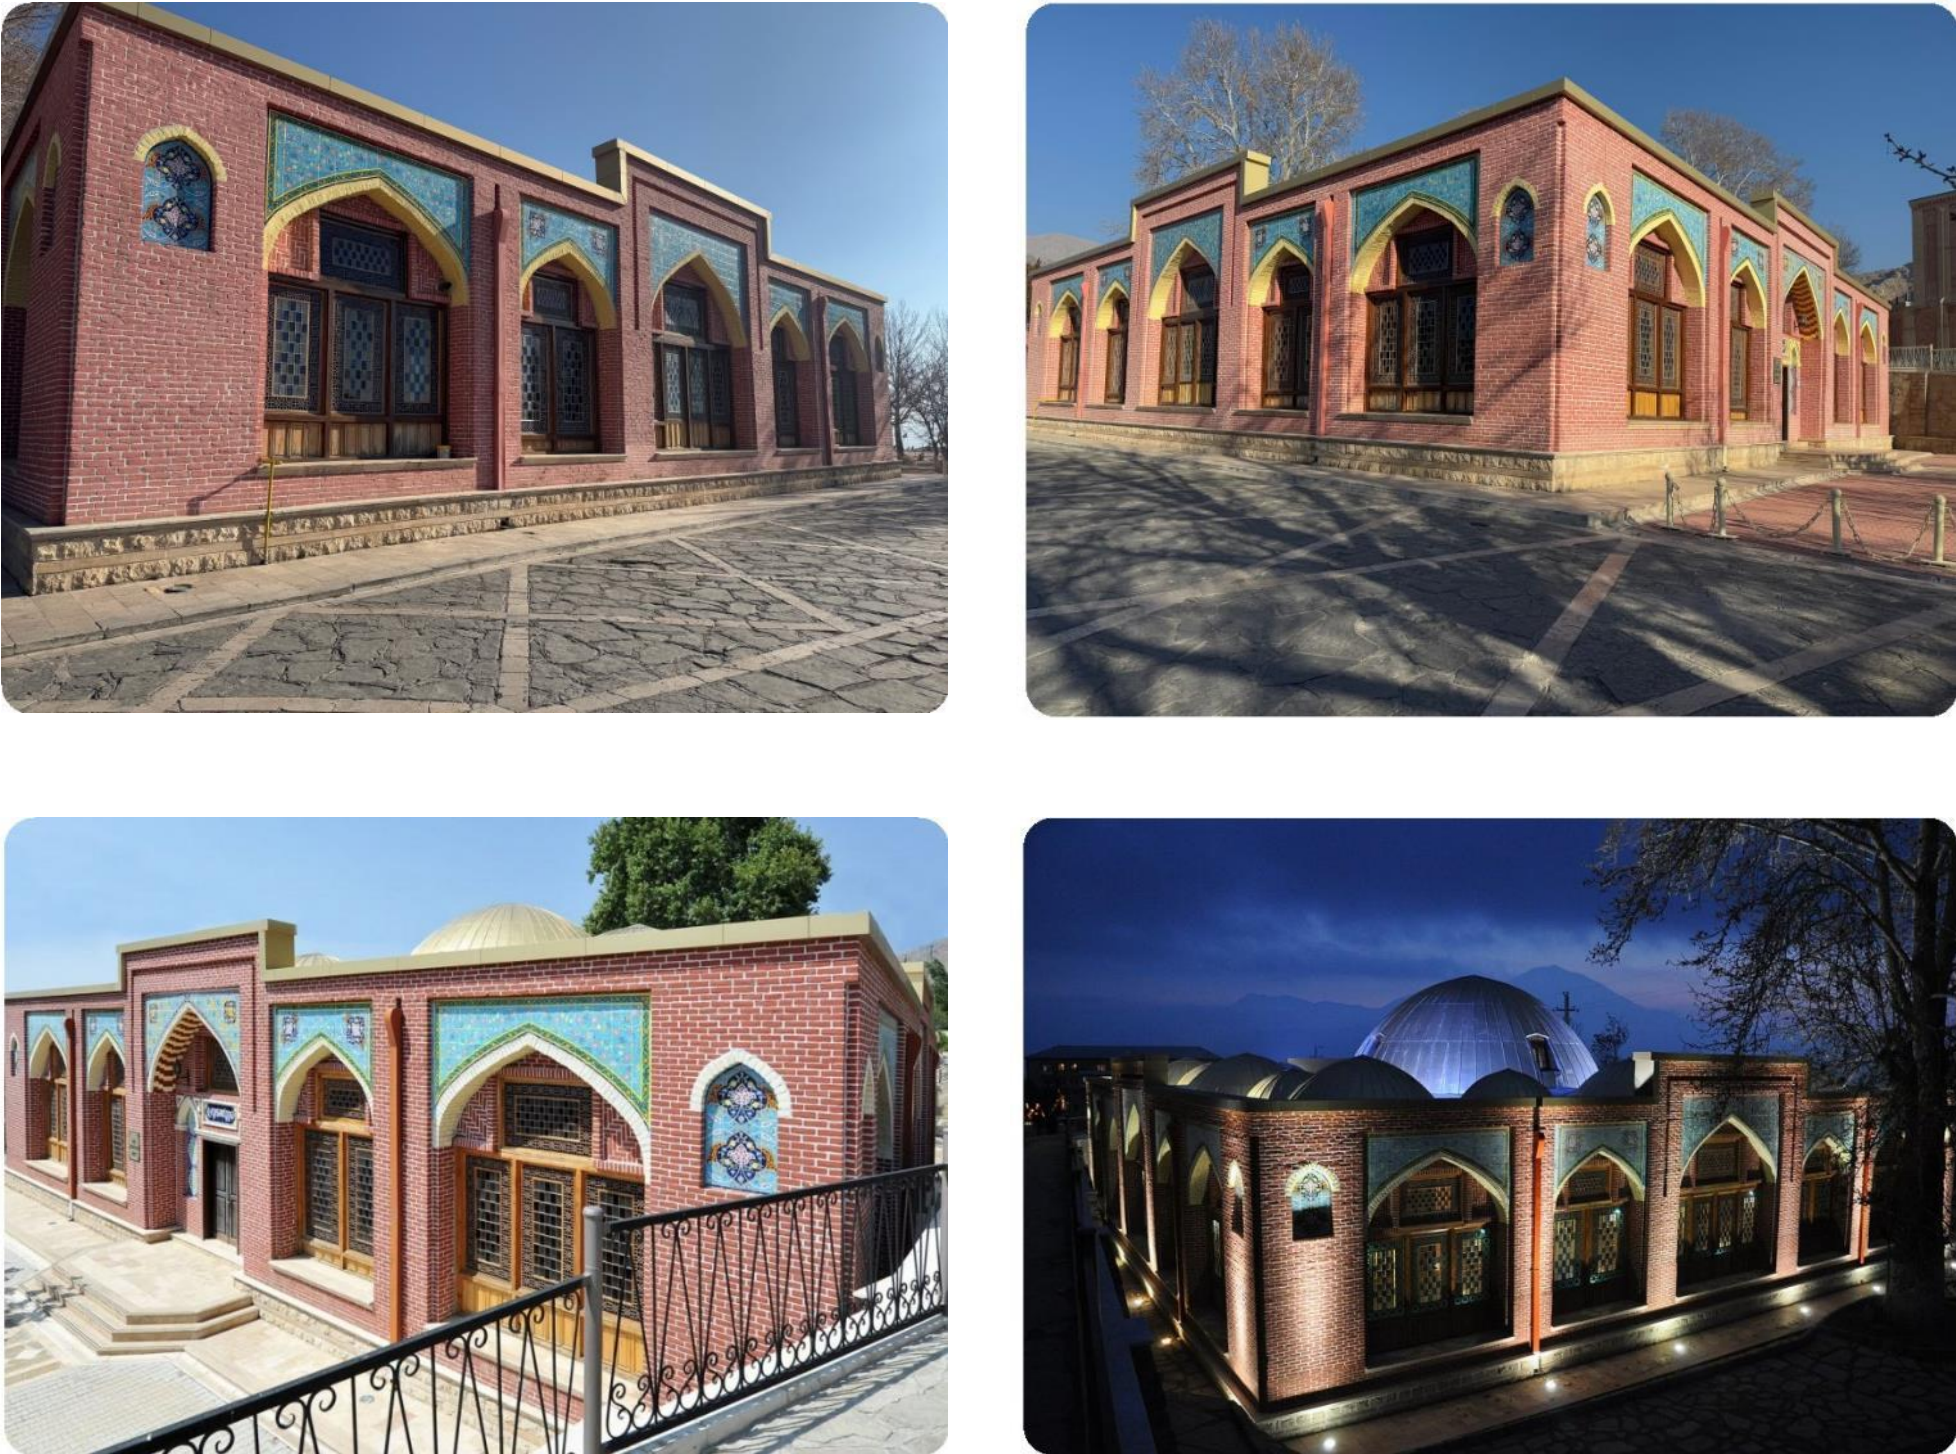
1. The current façade appearance of the building below

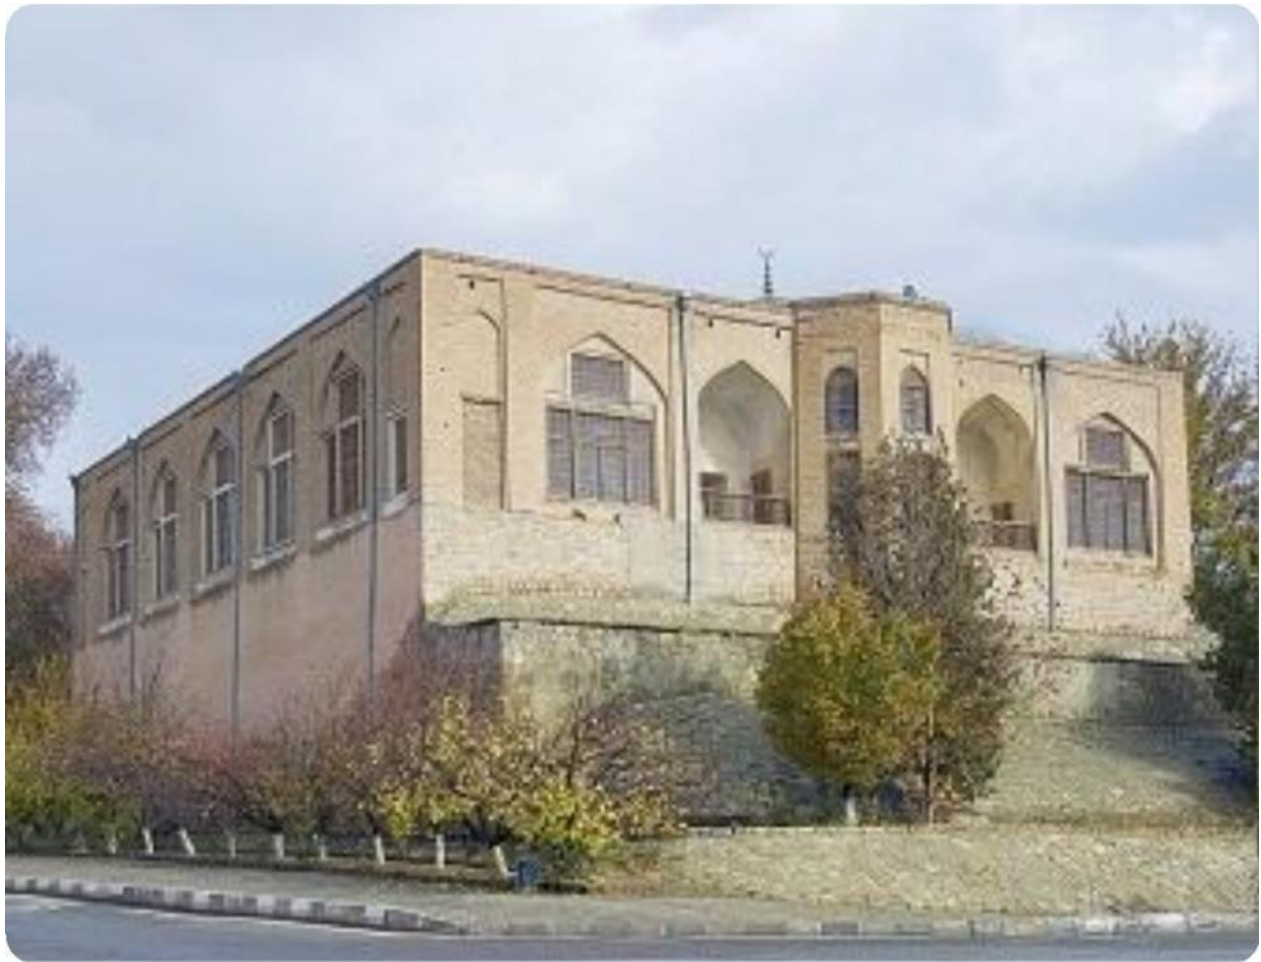
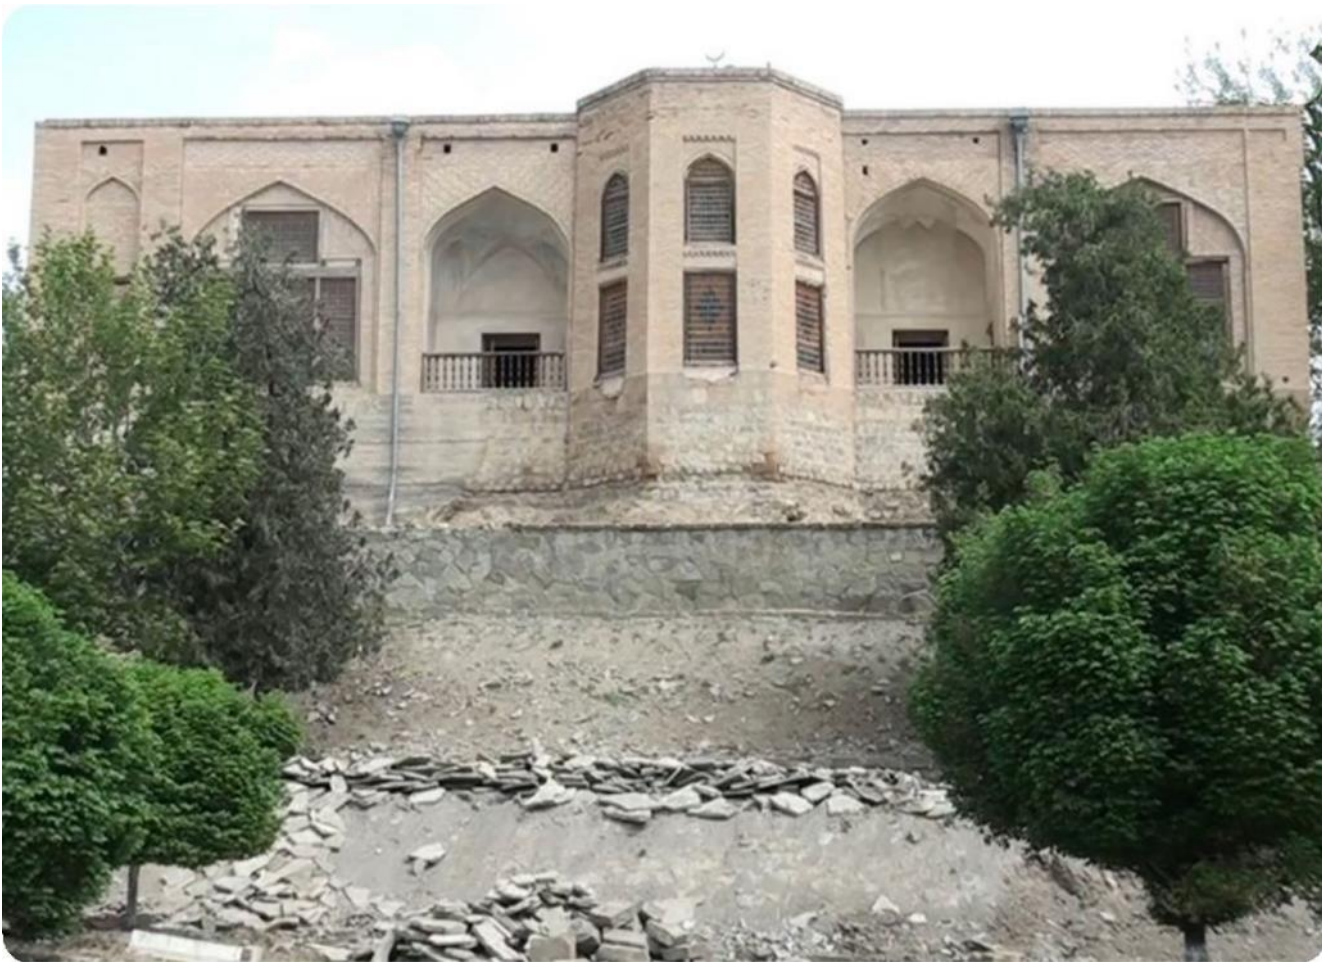
1. The condition of the structure before the last restoration

In the condition of the Ordubad Juma Mosque before the last restoration, we can see how the building impacted the landscape without the influence of the additional volume.

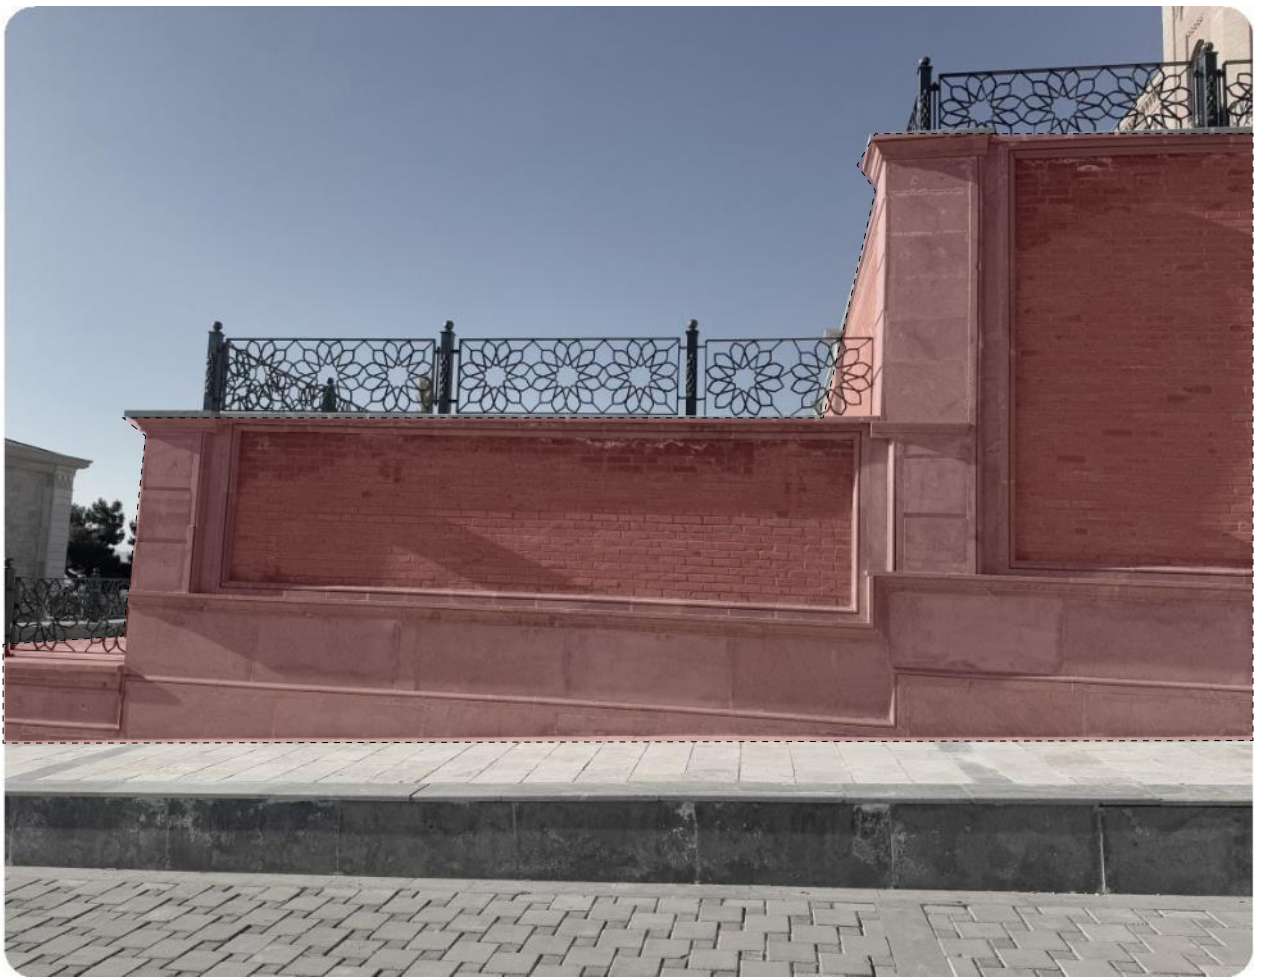
2. The current condition of the mosque

The Juma Mosque, located on the main street of Ordubad at a higher elevation, is a monument that significantly impacts the cityscape. The terrace-style extension added during the recent restoration, which serves no functional purpose, has a catastrophic effect on the volume of the structure.

The volume of the added structure

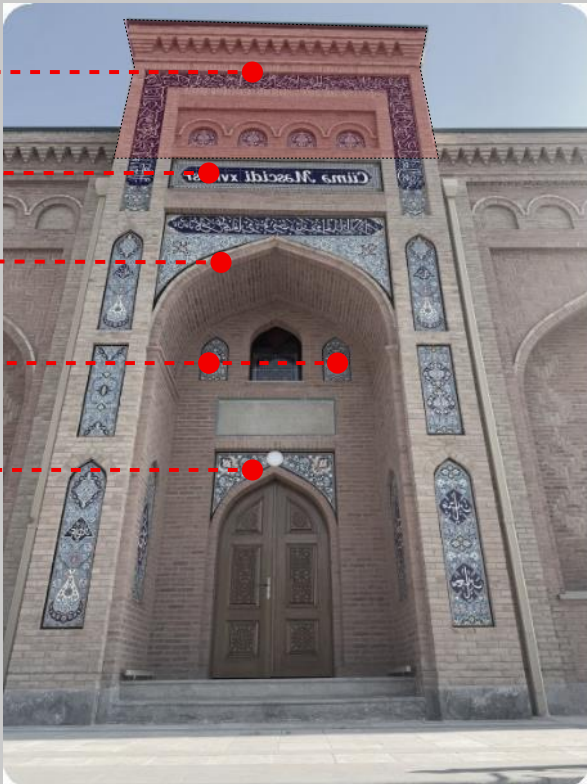
- In the pre-restoration image, the portal appears smaller. During the restoration, it was elevated.
- In the pre-restoration photo, there are no niches on either side of the window opening above the door.
- The inscription "Cümə Məscidi" is in Latin script, while the writings on the plaque are in Arabic.
- A modern ceramic detail is present above the door, and the materials used in the portal are different overall.

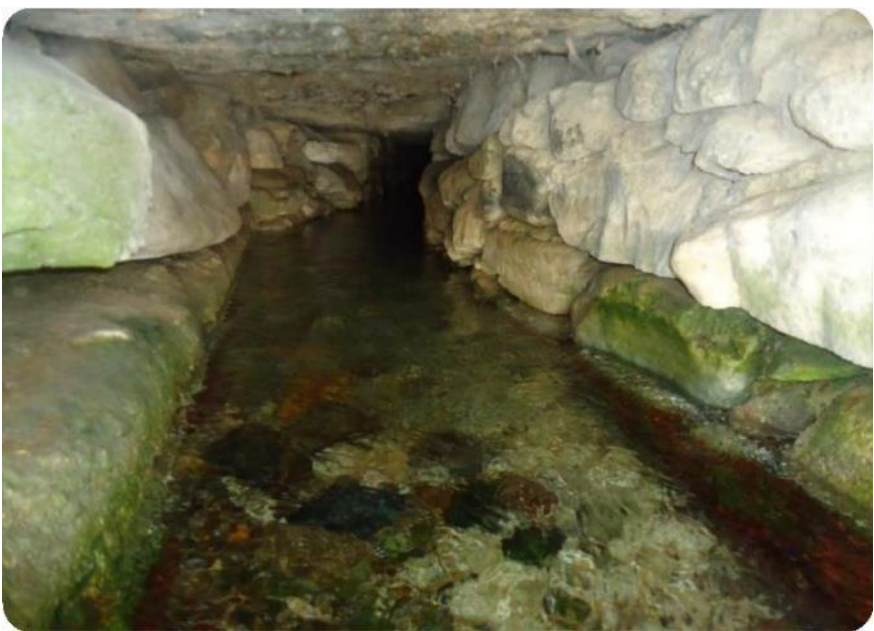
Kahriz tunnel

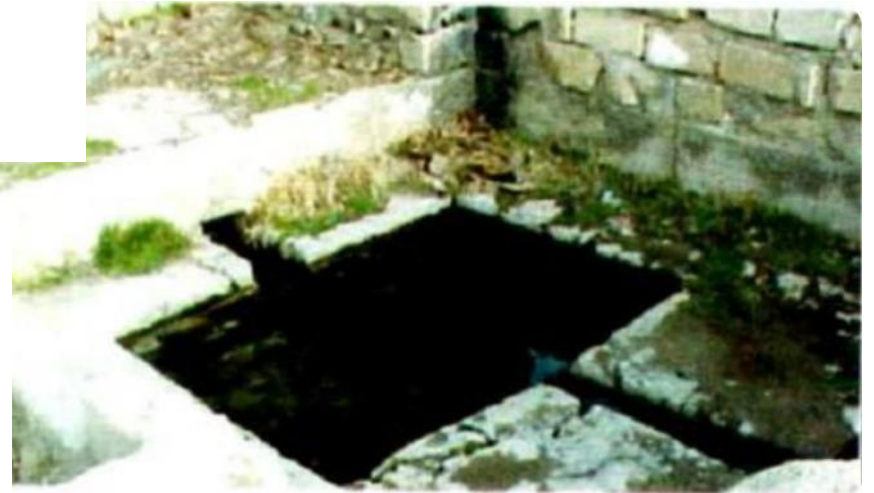
Kahriz cheshme

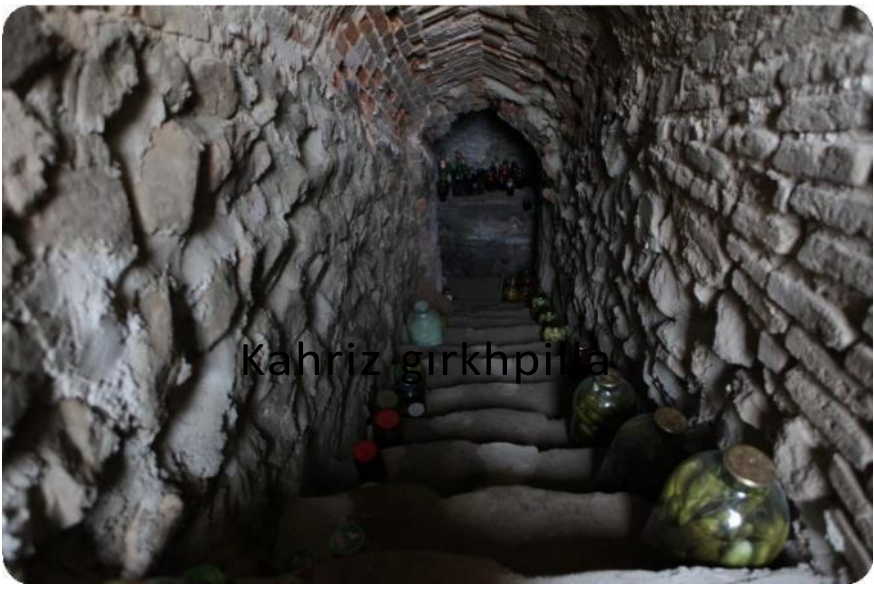
Kahriz girkhilla

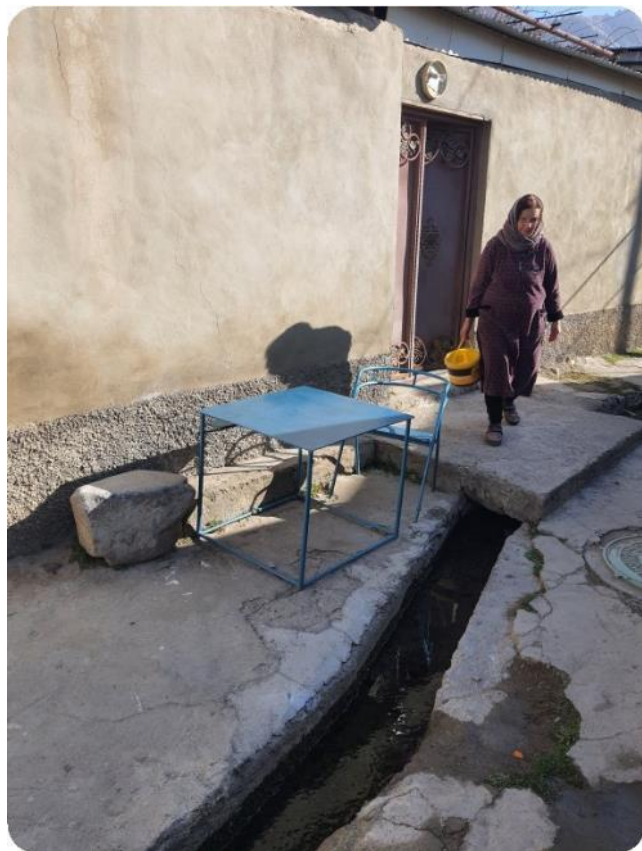
The Kahriz lines along the main streets between neighborhoods

Kahriz access points are mainly in neighborhood squares, with main pipelines running along major streets. Some structures are beneath houses or pass through yards. Despite its age, the Kahriz system remains a crucial source of clean water for Ordubad's residents.

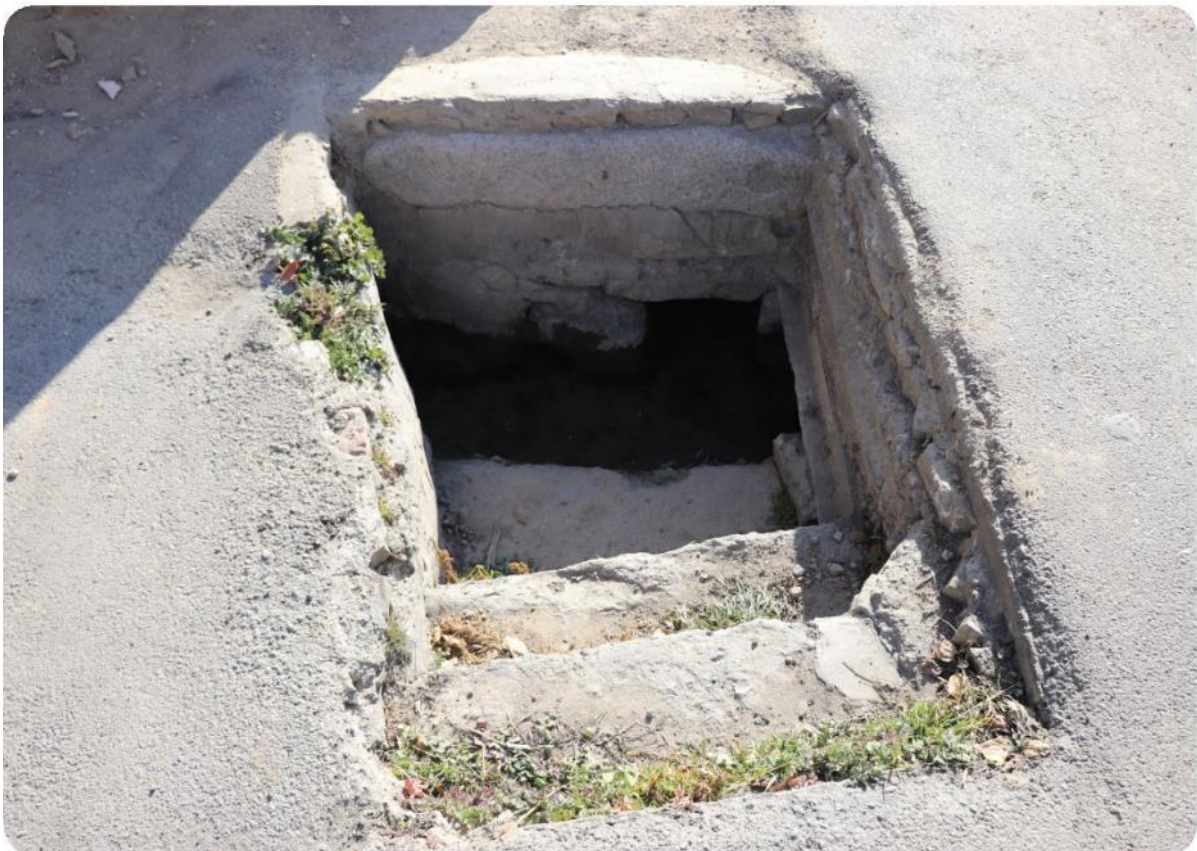
A distribution point of the kahriz water supply system

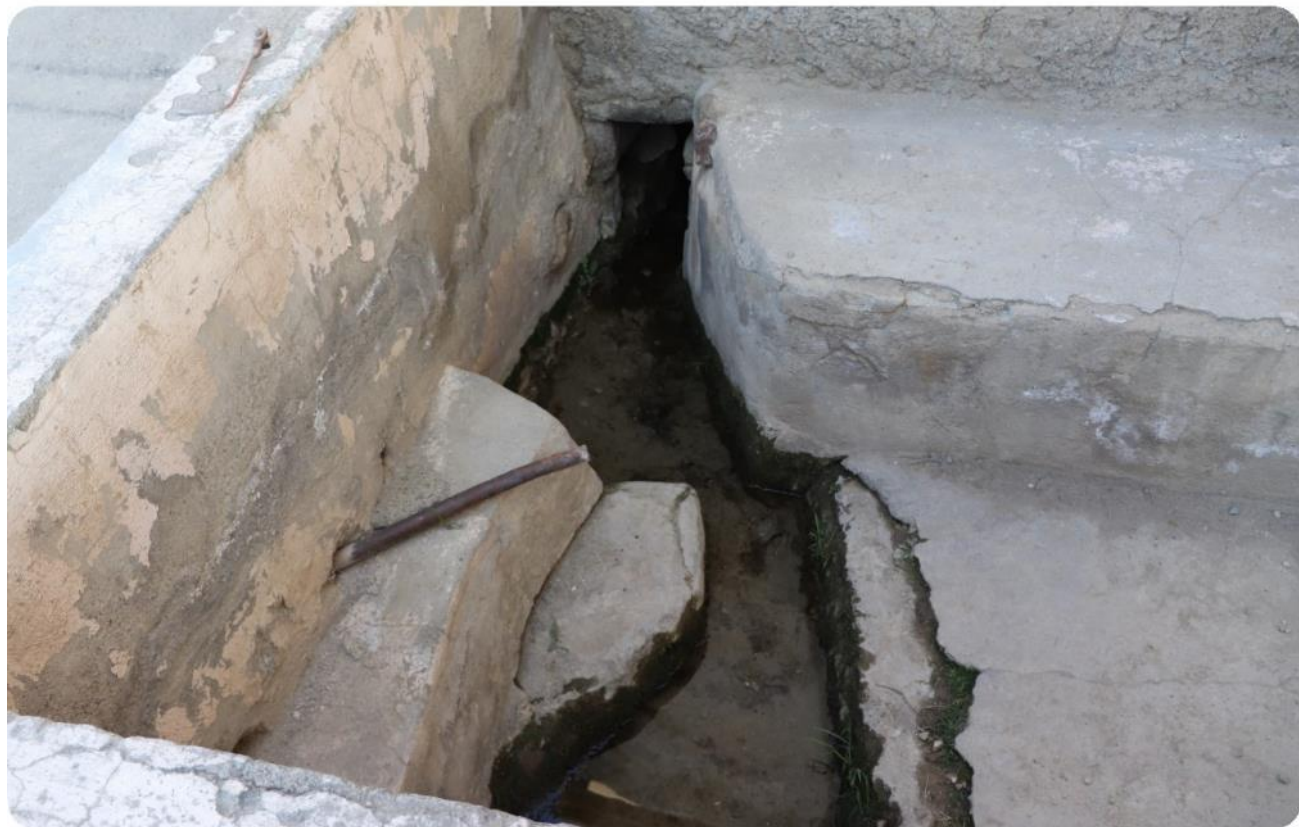
The Kahriz line that flows under the residential house

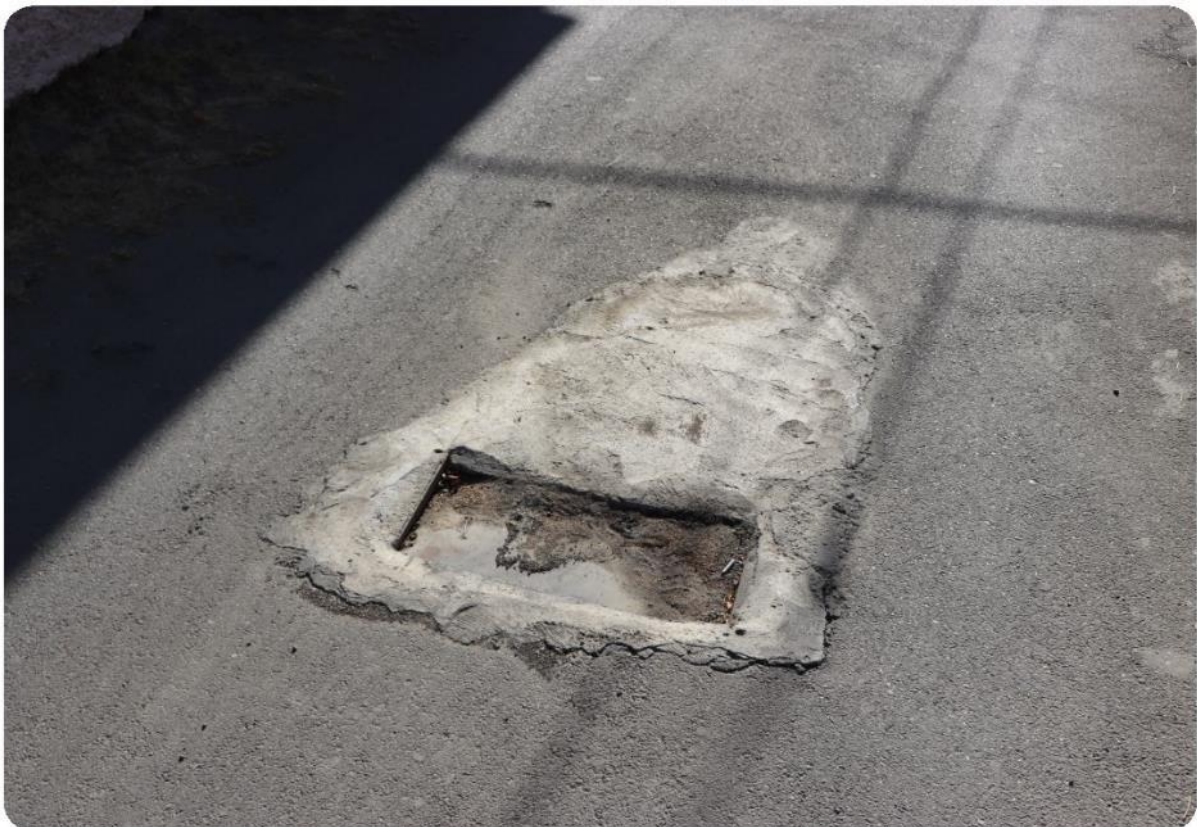
A Kahriz access point covered with an iron lid on streets with vehicular traffic

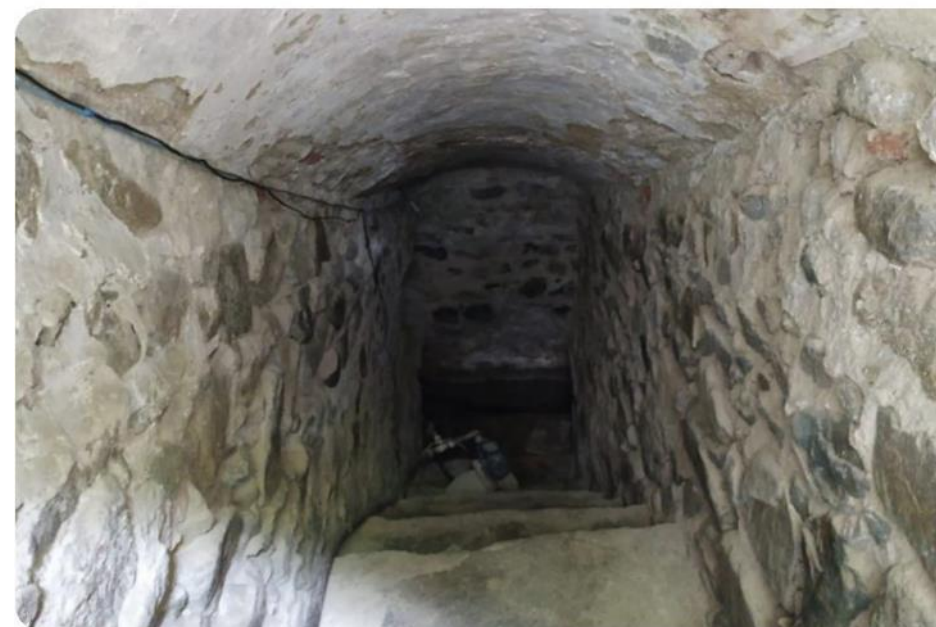
In front of the Sərşəhər Mosque, two different typologies of the Kahriz system can be observed. One of them is an access point known as Qırxpillə, where a stairway leads down to a deeper section of the Kahriz. The other is an above-ground typology, functioning as a fountain. This fountain also serves as a junction and distribution point, where pipelines from the upper neighborhoods converge, and water is further distributed to the lower neighborhoods.

This Kahriz access point was in good technical condition, requiring only regular annual maintenance. It is actively used by the local community, and when major issues arise, the residents themselves take the initiative to resolve them.

Sersheher QirxpillaSection and plan

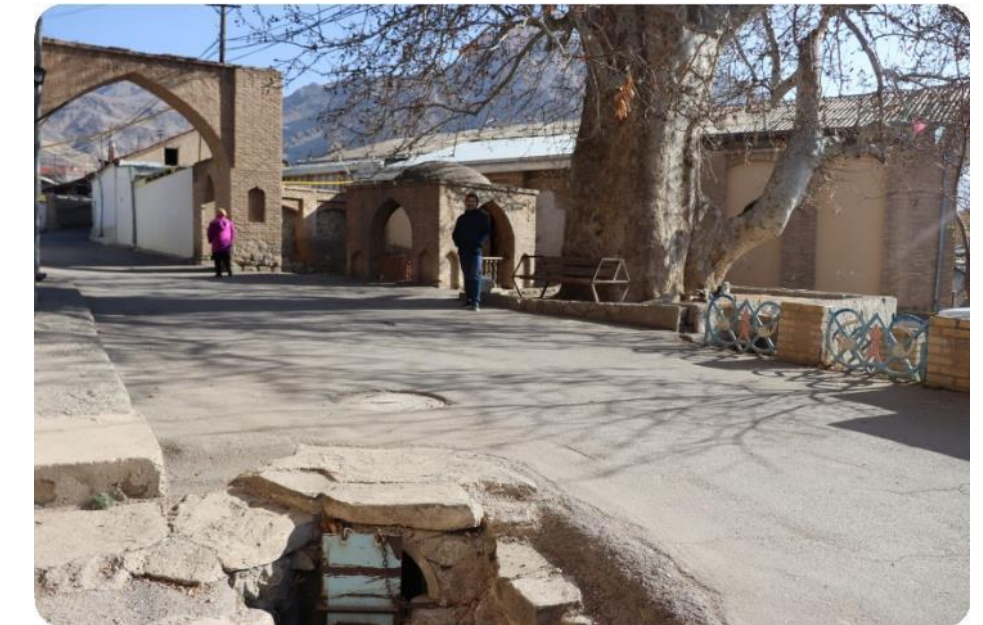
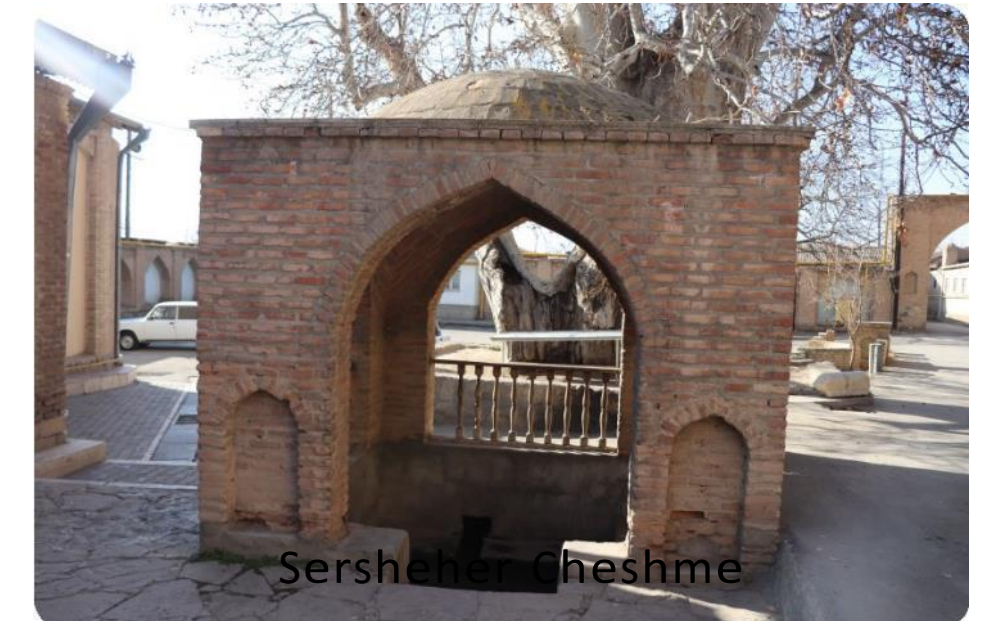
Sersheher Cheshme

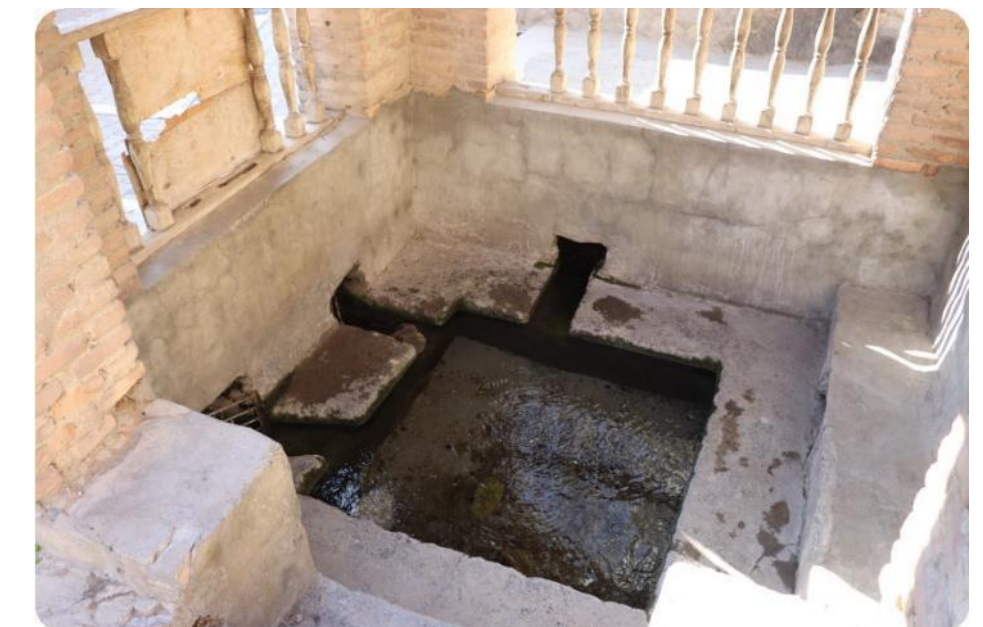
Sersheher Cheshme

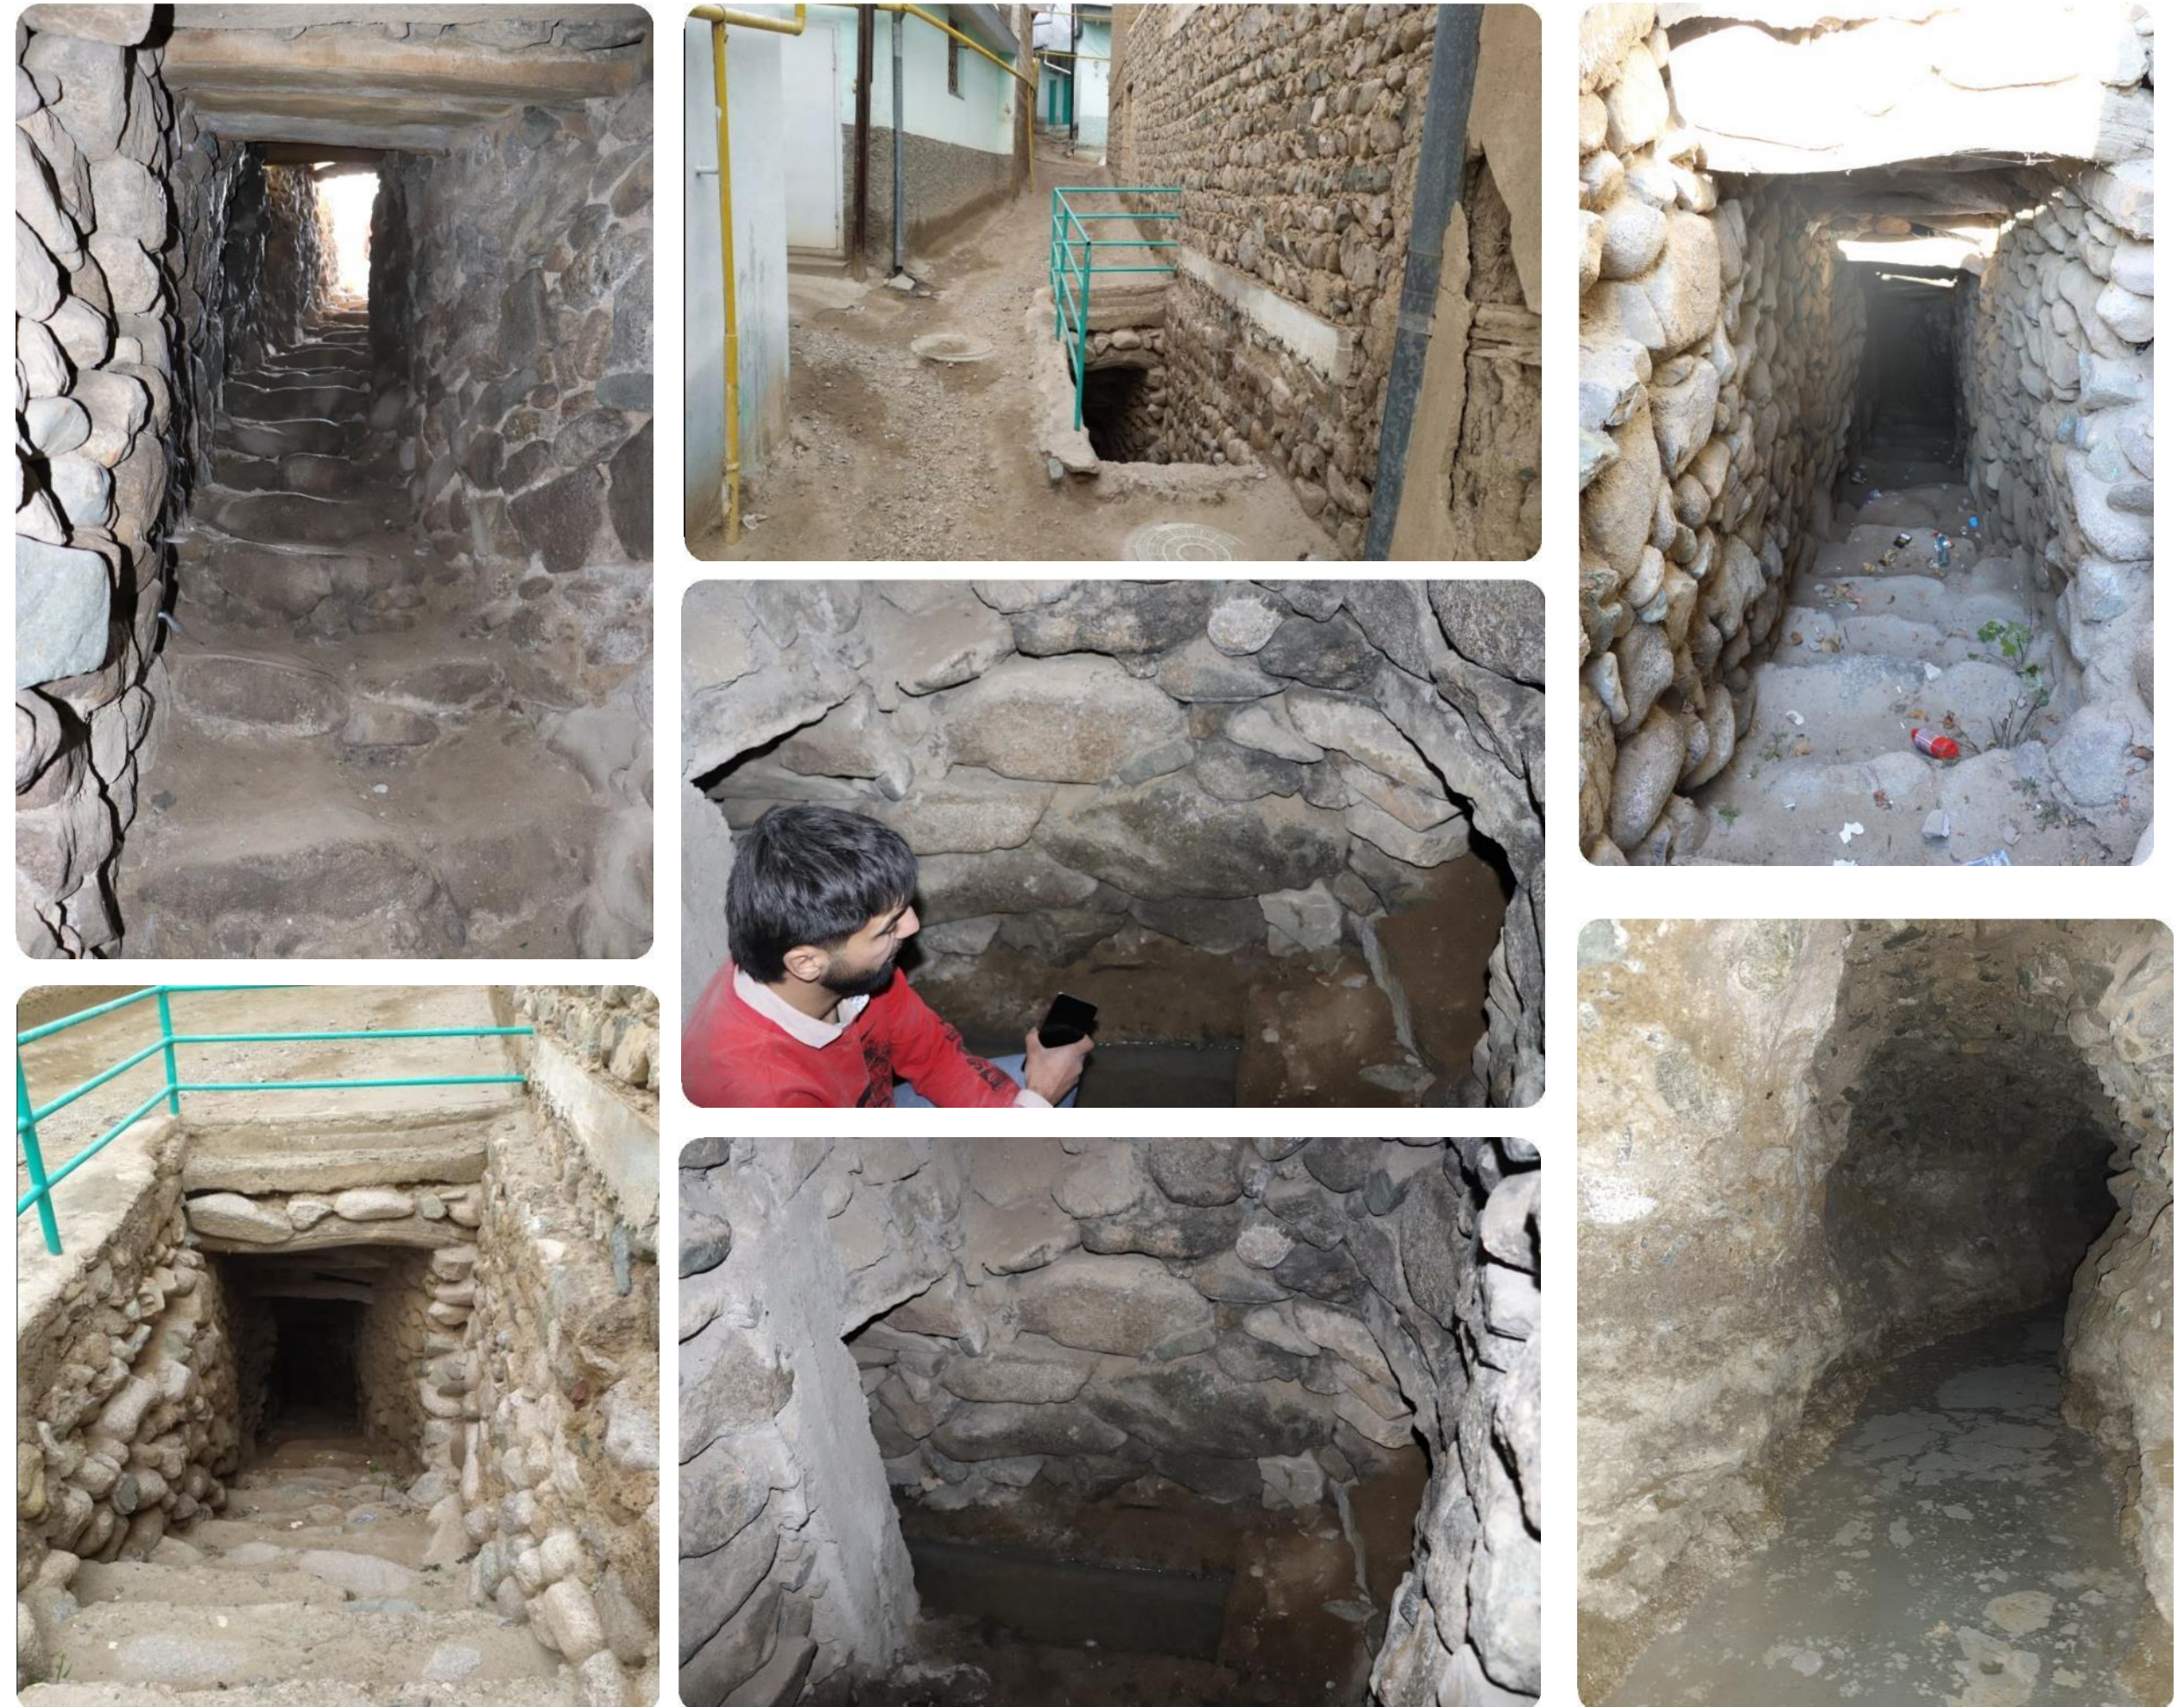
The overall condition of the Kahriz is assessed as good; however, waste disposal by children at the staircase section has been observed. Additionally, partial blockage and malfunctioning of the system in certain sections lead to water shortages in the lower-lying neighborhoods. To prevent such disruptions, regular and continuous maintenance is essential.

The current condition of the Girkhayag kahriz
