Caucasus Traditional Building Revival

Case Study Report

THE HISTORICAL URBAN LANDSCAPE OF ORDUBAD: RESTORATION OF MONUMENTS, THE ROLE OF GARDENS, AND THE KAHRIZ WATER SYSTEM

TRADITIONAL ALIZI (ADOBE BRICK) HOUSE IN GEORGIA

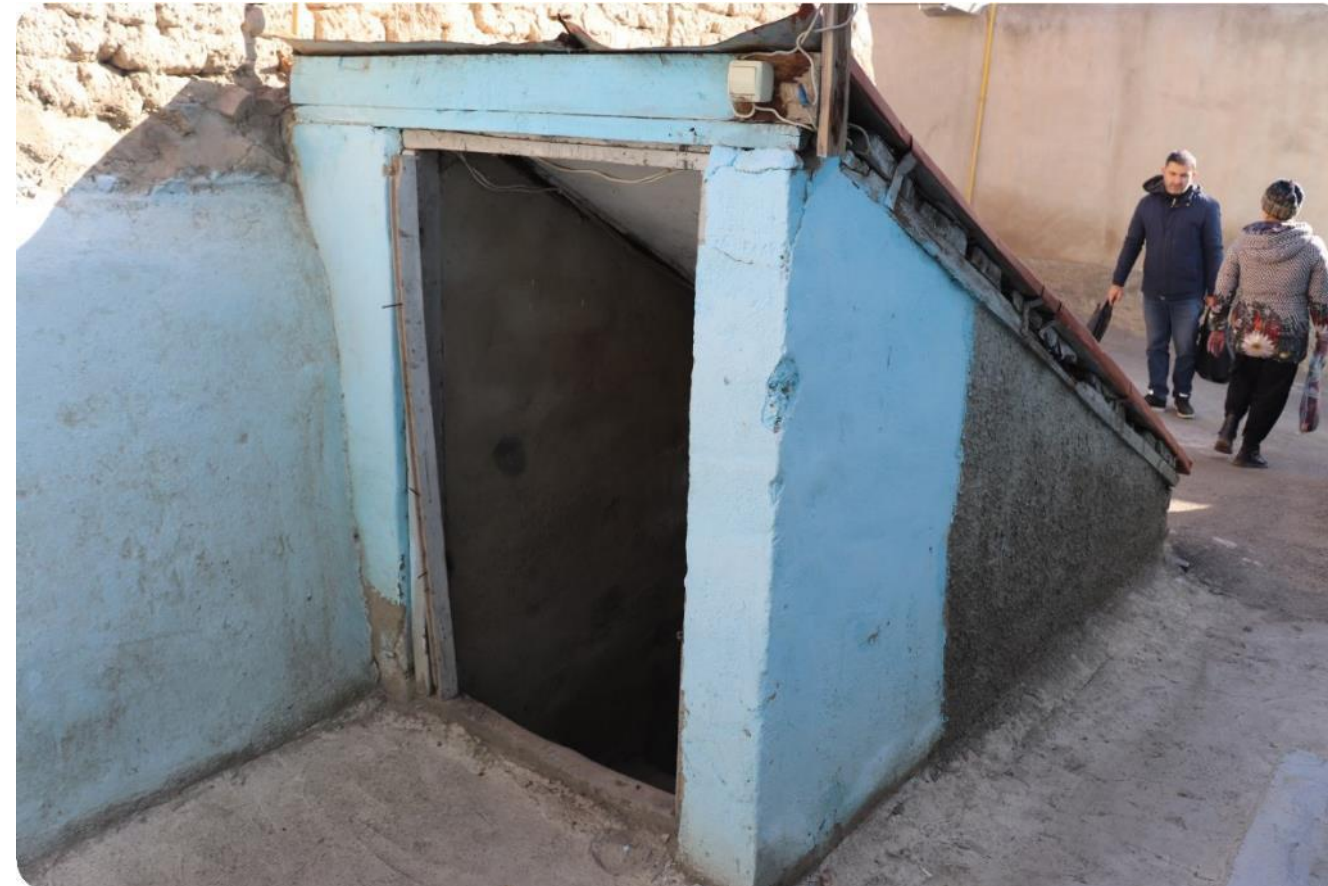
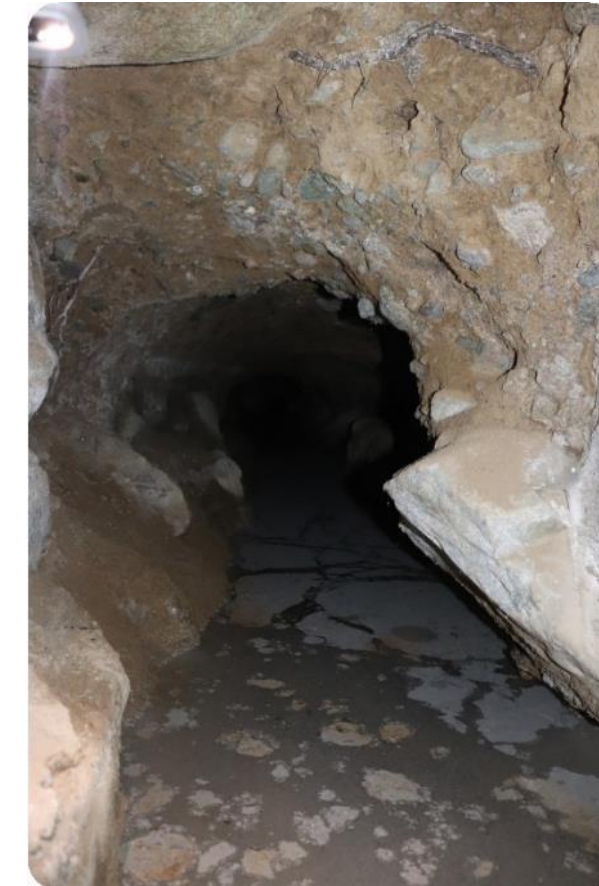
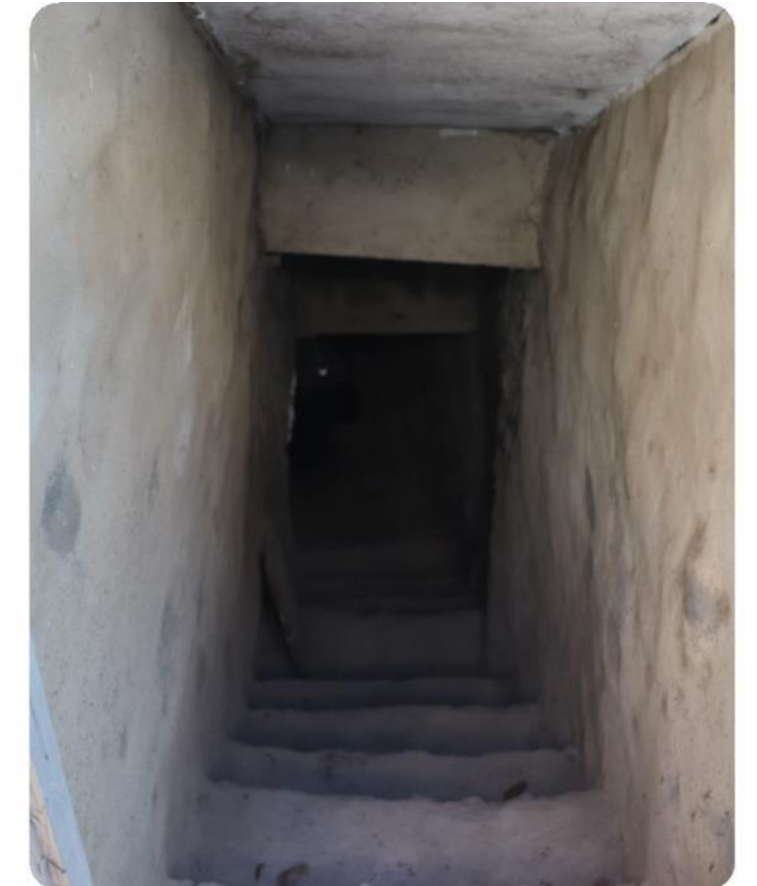
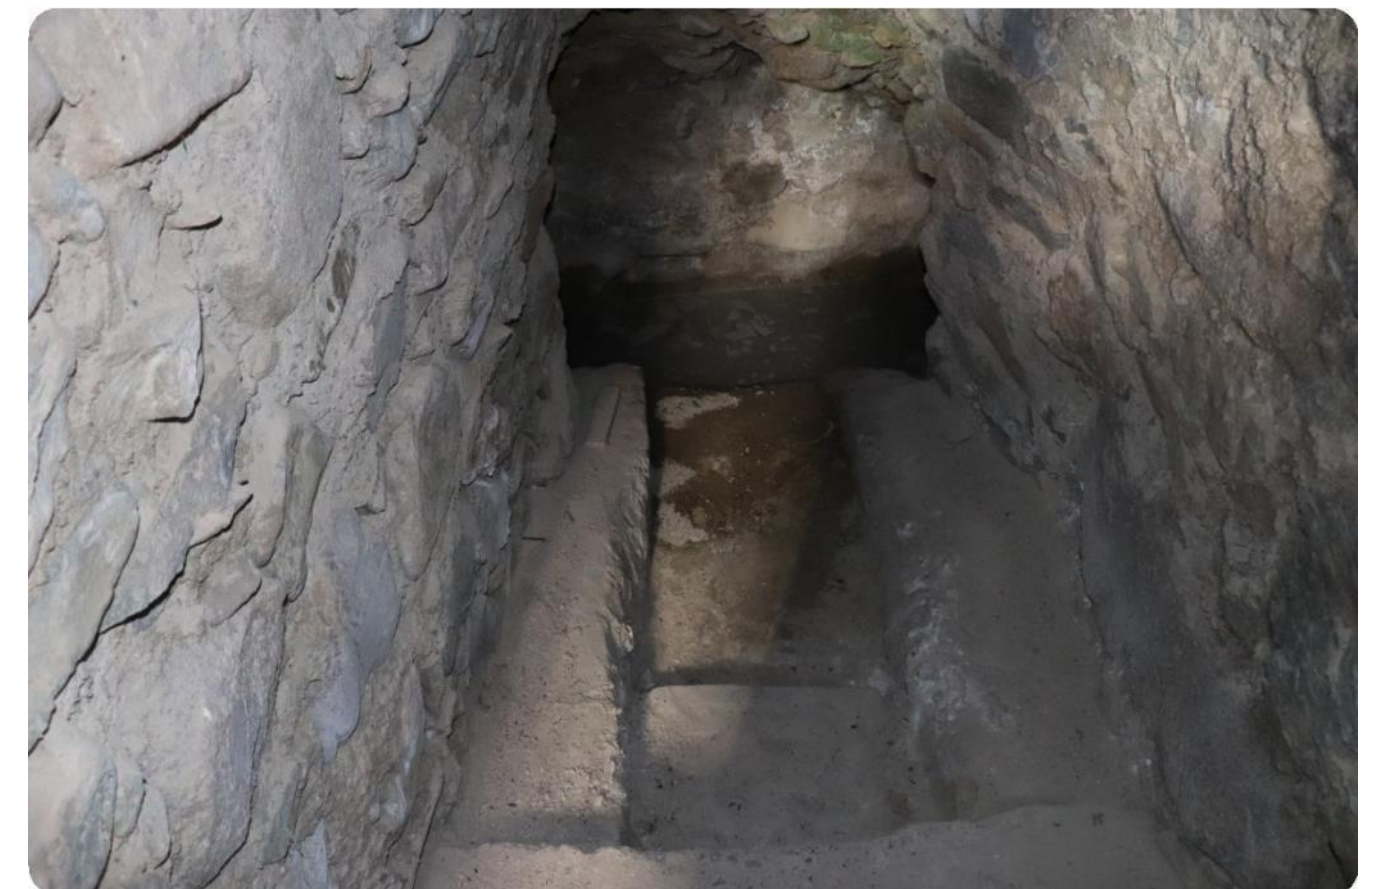
The Mingis Kahriz, located in the Mingis neighborhood, is situated at a depth of approximately 17–18 steps. Due to its position between two residential houses, it is not immediately recognizable as a Kahriz; however, it was identified using a map. The system remains actively used by the local community.

However, since it is currently winter, maintenance of the Kahriz has been incomplete, leading to a weakened and eventually halted water flow. Despite this, the overall condition of the Kahriz is assessed as satisfactory. Surveys conducted among neighboring residents revealed that the local community actively participates in its cleaning and maintenance. This cleaning process is observed as a significant communal event.

The current condition of the Mingis kahriz

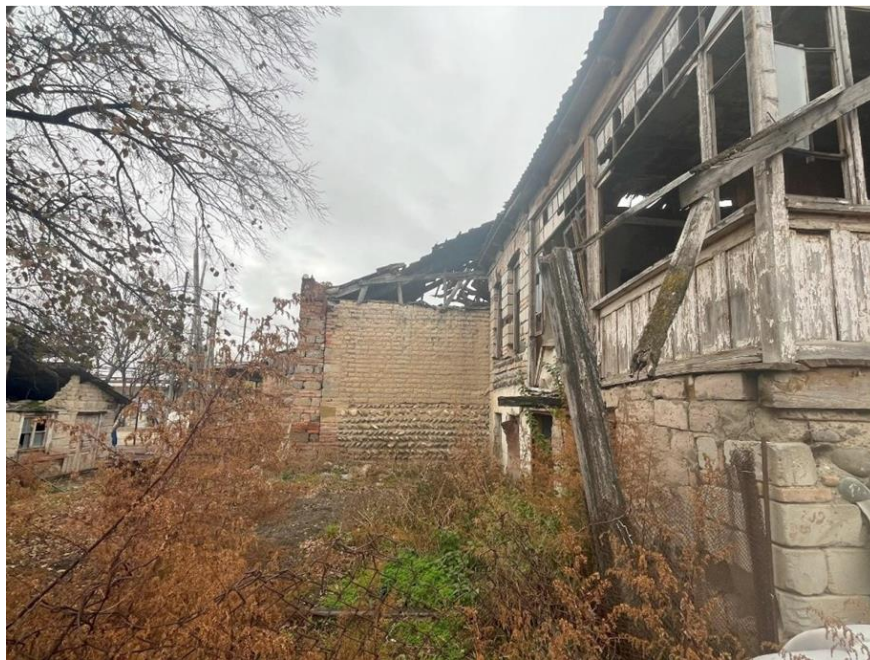
Mixed building materials. Ruisi.

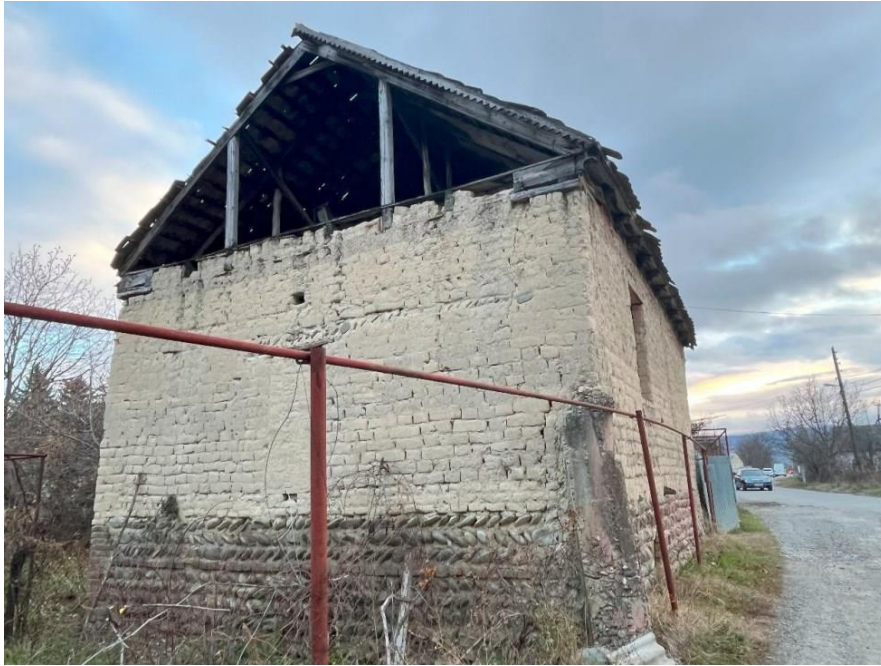
Patara Garejvari

In older structures, interior partitions are sometimes made with timber planks finished with an Alizi coating. Most Alizi walls are built with three rows of Alizi bricks (typically 27x17x8 cm or 33x17x8 cm), bound with mud mortar and finished with Alizi plaster. The houses generally follow a simple quadrilateral floor plan, typically comprising two enfiladed rooms. The structures are straightforward, without wooden frameworks in the walls. Timber is used primarily for the floors and ceilings. Roofs are gabled timber structures, covered variously with tin, tiles, or fiber cement sheets. The attics feature relatively steep pitches, with an inclination of 30–40%. Almost all houses include wooden balconies or galleries adorned with decorative openwork.

In buildings where Alizi is used on the ground floor, the foundations are constructed with river stone to minimize the effects of rising damp. Most Alizi houses are scattered throughout the historic urban fabric of these villages and are in poor physical and structural condition— often abandoned or neglected. In many cases, Alizi was later used on second floors or side walls as an infill material during repairs in the 20th century. Only a few traditional Alizi houses remain in use and are actively maintained. These structures do not have basements, which sets them apart from other older vernacular typologies in Eastern Georgia, such as the Darbazi.

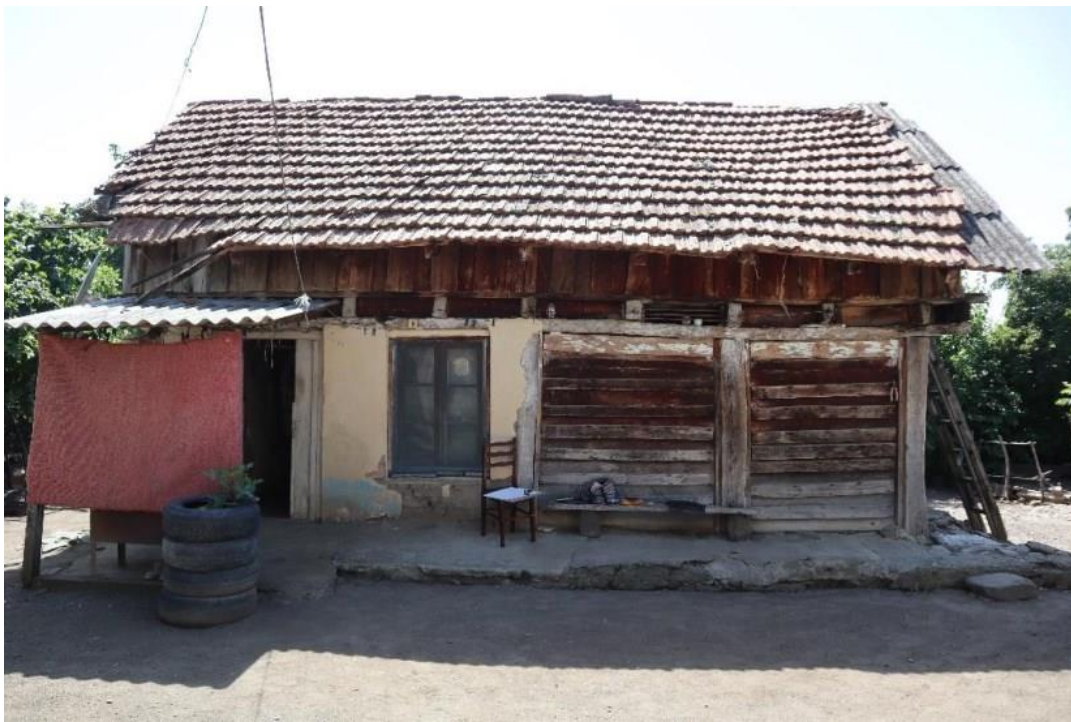
Dimitri Barkhudarashvili Traditional House in Zinobiani

one half is made of adobe brick and built on a foundation of river stone, while the other half is made of wooden framework with infill of boards. The entire structure was originally plastered and whitewashed with lime, including wooden part, although much of the plaster has now fallen off.

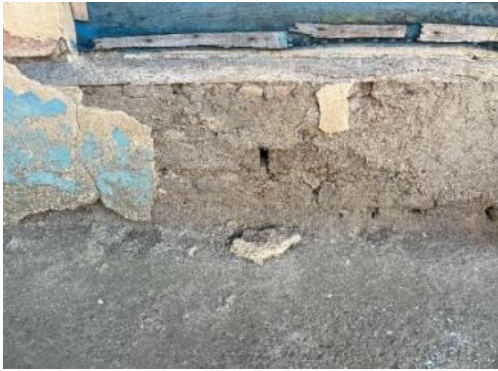
Sample 1. Interior: The average grain size of the deposit shows a filler-to-matrix ratio of 3:2, with a particle size distribution ratio of 1:18:13 (water, binder, aggregate).

Sample 2. Interior: fine -grained deposit shows a filler to matrix ratio 1:1, with a particle size distribution 1:19:22 .

Four samples of alizi were taken for laboratory testing: two samples from interior and two samples of Alizi Brick.(Annex1)

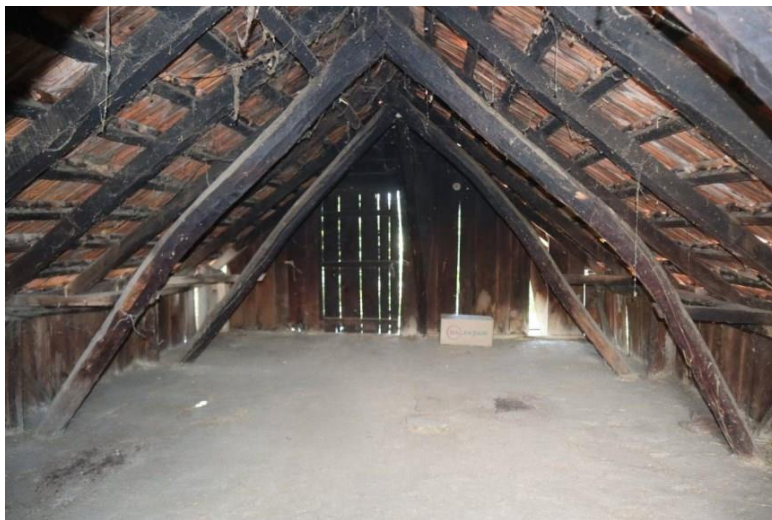
Attic Zinobiani House

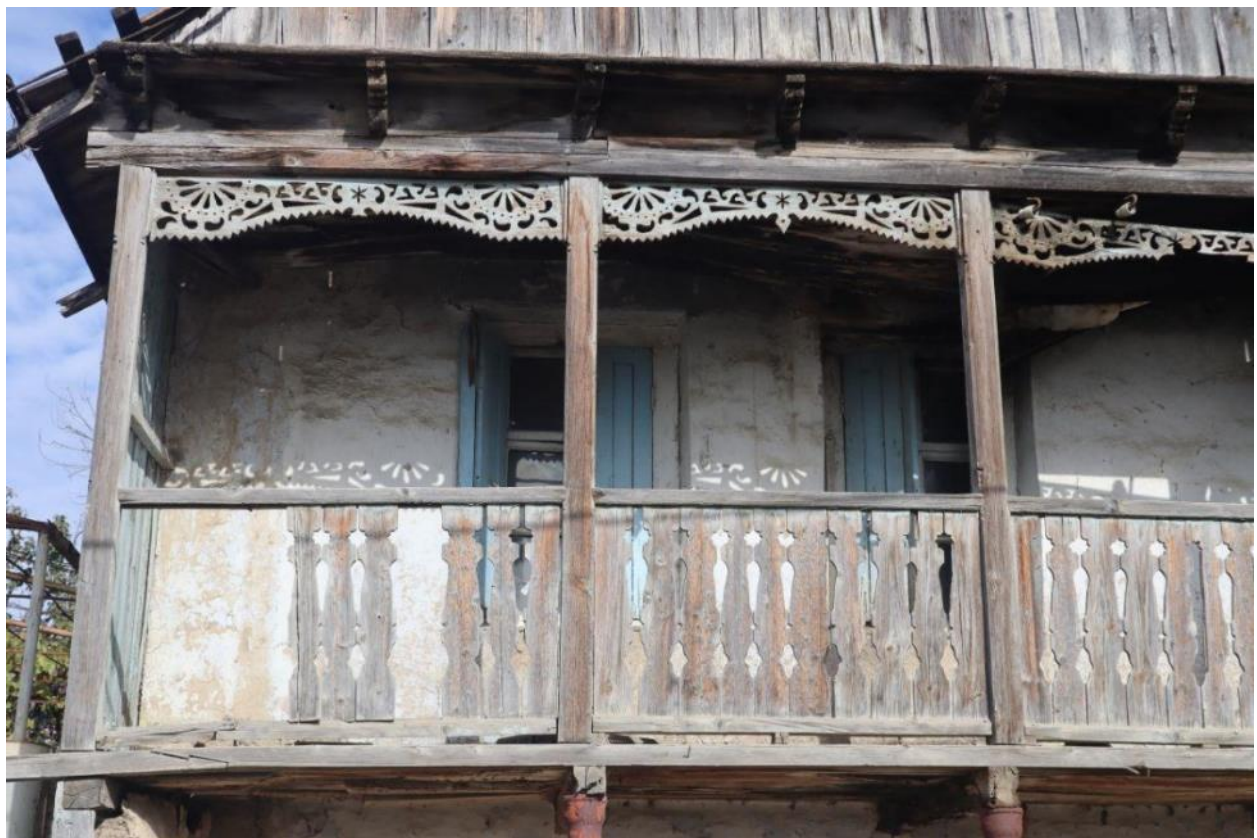
are arranged with wooden framework. Wooden beams are used for inter-floor and roof framework. No wooden members are used for the wall. Adobe walls are laid down with three line of adobe brick and equals 45-46 cm. Coating is randomly preserved at the lower parts of the wall. Wooden Balconies are decorated with openwork of traditional Georgian pattern.

Wooden openwork of Iliatsminda Balcony

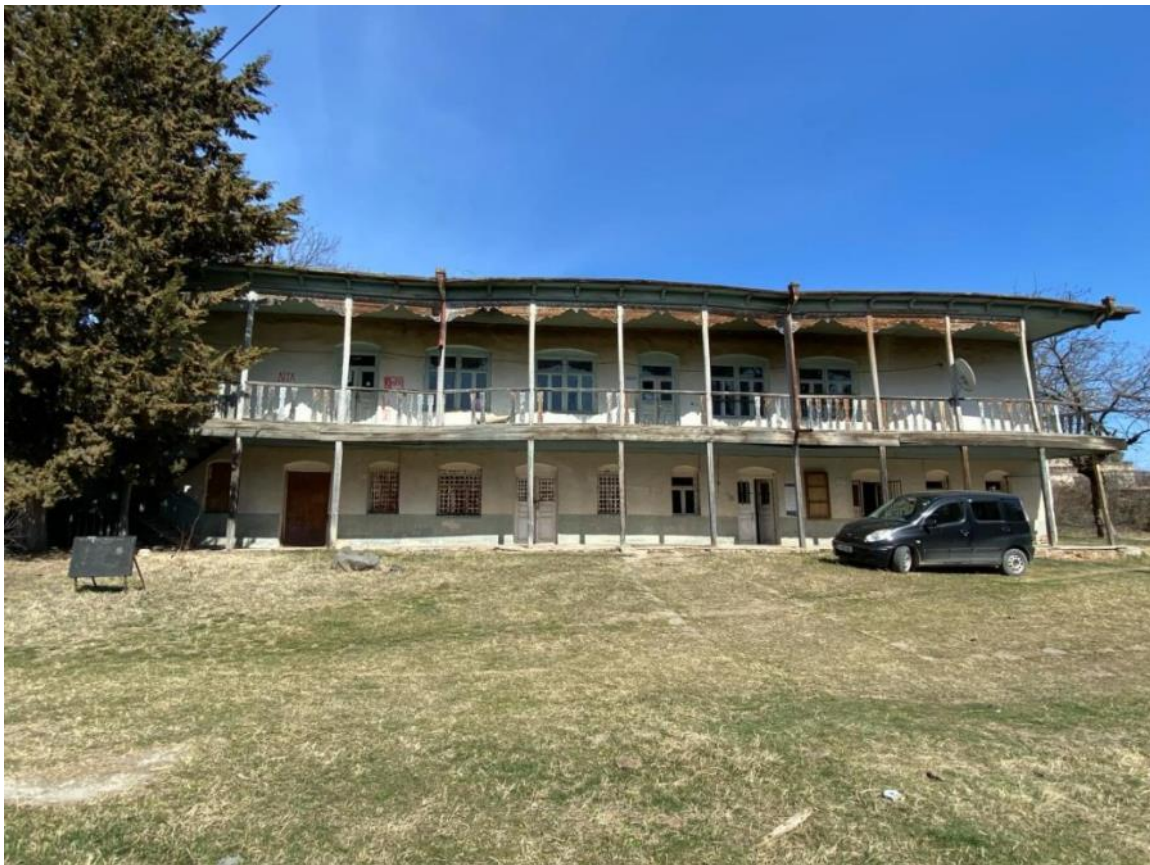
Apart from dwellings, a former school building from adobe brick is also preserved in Iliatsminda. This building is distinguished with its size, large rooms and interior details decoration elements of Georgian tradition.

Former Adobe School Building in Iliatsminda

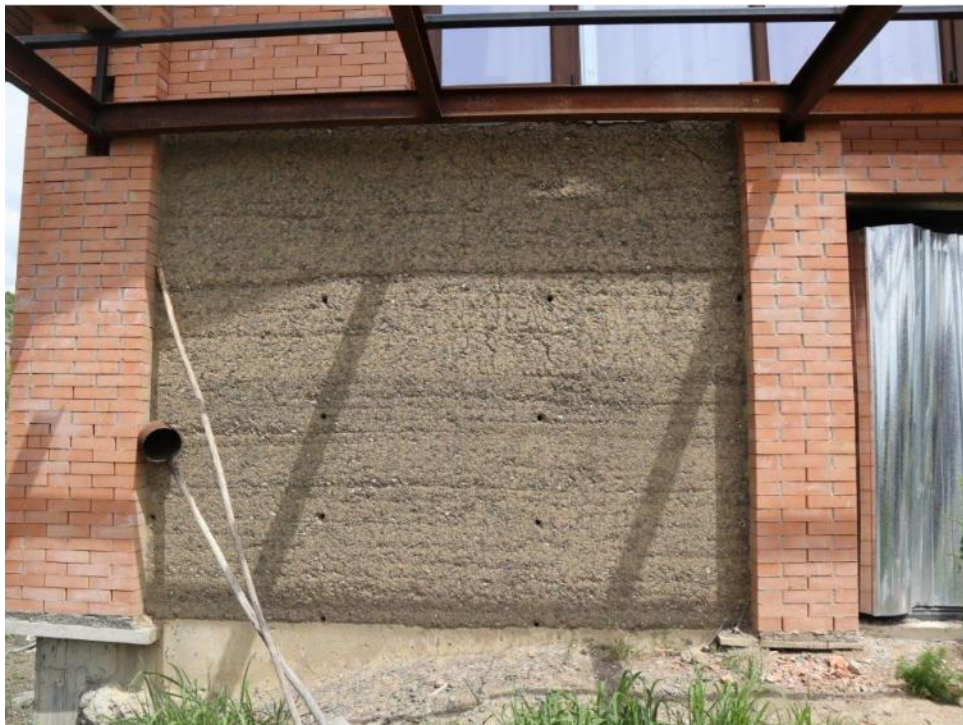
This initiative was truly international in scope: French experts from CRAterre-ENSAG, invited by both Givi Jakeli and the property owner, collaborated on the project. The team experimented with different proportions of clay earth and gravel based on earlier research. They constructed pressed adobe walls using timber molds. These earthen walls were then used as infill within a structural framework of brick and metal. The project also incorporated a variety of materials: some walls include wooden boards, while others integrate stone.

Gremi Wine Cellar

Near the historic Gremi Castle, architect Gocha Gigiashvili has built an experimental vine cellar using clay earth “panels.” Inspired by the pioneering work of Givi Jakeli, the project draws from the Alizi tradition and serves as a modern interpretation of earthen architecture in Georgia.

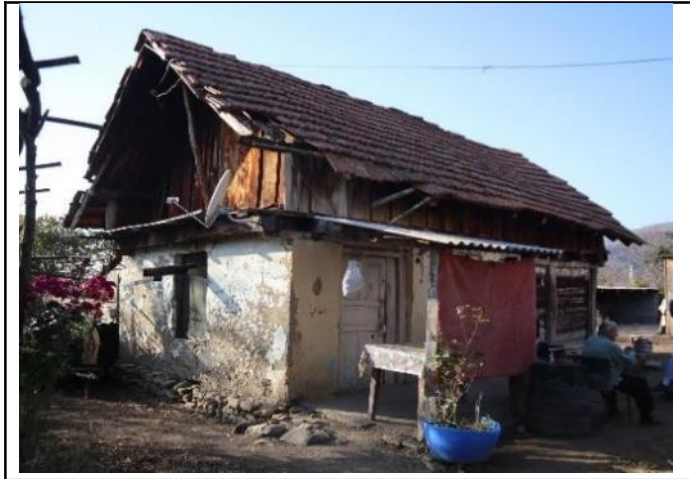
№

The condition of the building is poor due to age, neglect, exposure to sunlight, and damage to the roof.

As on the façades, much of the plaster has fallen off in the interior as well. Most of the wooden elements of the tiled roof and the wooden roof structure are deteriorated. Corrugated asbestos sheets (commonly known as "shifer") have been used on the outer sections of the roof. Currently, this single-storey structure is damaged and non-functional, and is mainly used as storage for household or agricultural tools.

ბუნებრივი/Natural	კლიმატური პირობები/Climat conditions
ადამიანის ზემოქმედება / human impact	მოუვლელობა / neglection
სხვა კონკრეტული მიზეზი/ other reasons	სიძველე / aging

The damaged roof poses a threat to the entire building. It is essential to promptly repair the deteriorated roofing, replacing the old, damaged wooden elements with components of identical shape and profile. The tiled roofing should be renewed using flat tiles of the same form and dimensions. The walls need to be plastered, both on the façades and in the interior. The door and window frames also require restoration and repair.

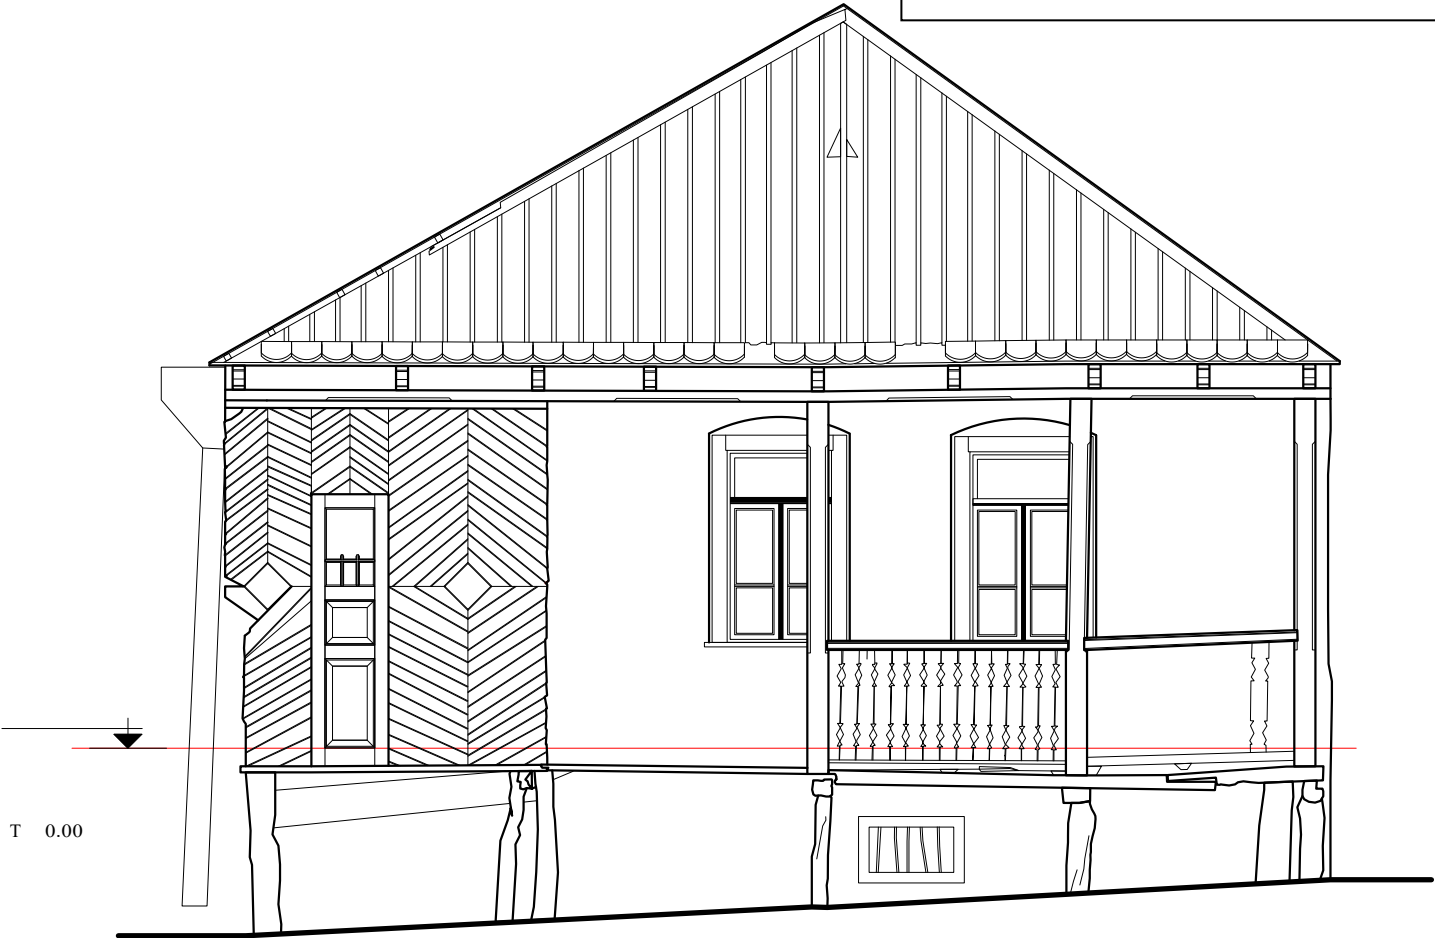
North Elevation
scale 1:50

Measured Drawings of elevations of Romanoz Kandashvili house
in Iliatsminda
